# Slys Quarry, Tullmorgan- Jackbulbin Road, Mororo

**Annual Review**

Mororo Quarry Pty Ltd

3 December 2024

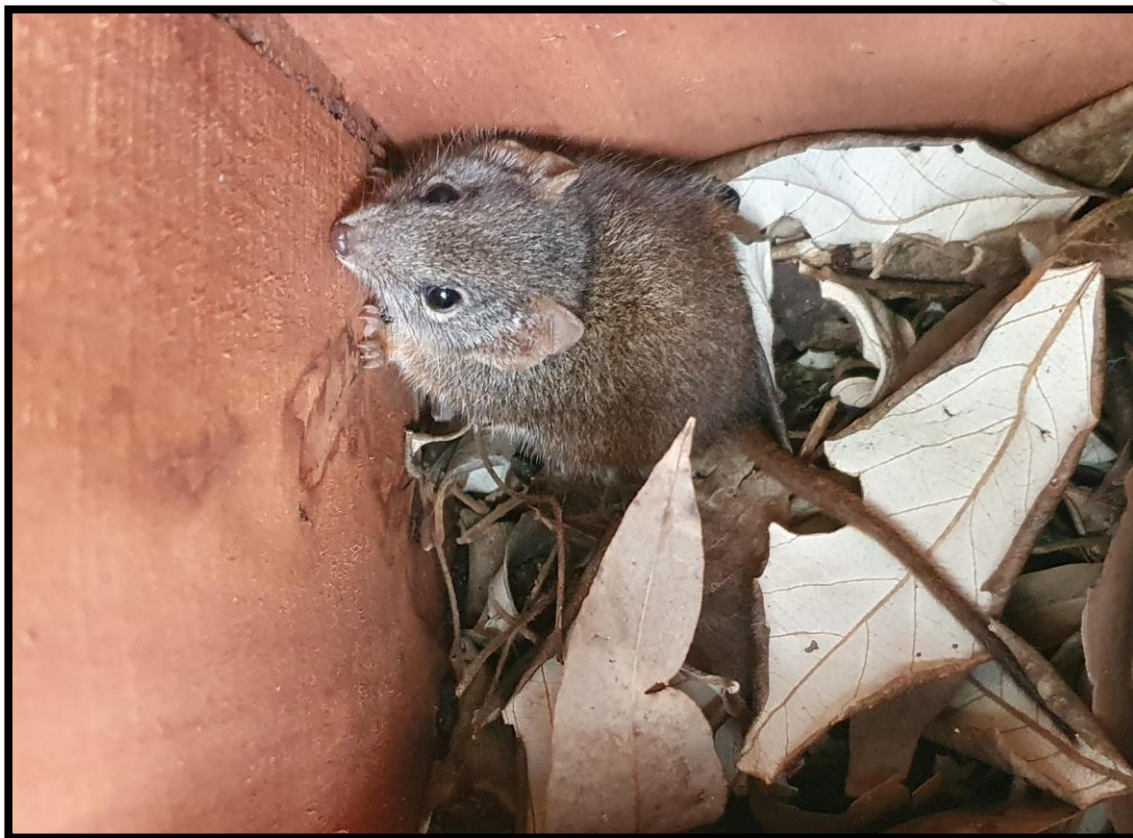
**Plate 3-1.** Yellow-footed Antechinus from Stage 2 nest box installation area.

- Yellow-footed Antechinus (*Antechinus flavipes*) using a scansorial type box installed as part of Stage 2 works (Plate 3-1);
- Sugar Gliders (*Petaurus breviceps*) using some of the scansorial and small glider type boxes (Plate 3-2);
- Lesser Long-eared Bats (*Nyctophilus geoffroyi*) using some of the multi-chambered bat boxes including one observation of six individuals and the presence of many scats on the ground indicating some sustained use (Plate 3-3).

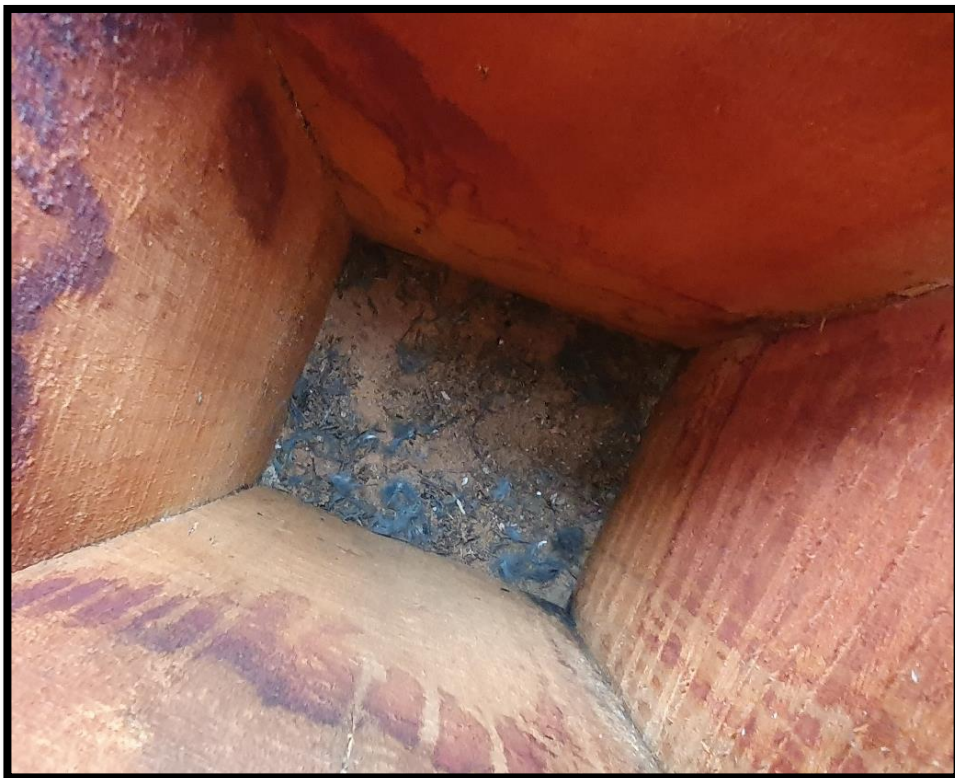
**Plate 3-4.** Nest box used by Australian Owlet Nightjar.

Indirect signs in the form of nesting materials were observed at the remaining 20 boxes and included glider nests, shallow cupped areas of leaves indicative of brushtail possum use, antechinus nests and scats plus bird nests (Plate 3-4).

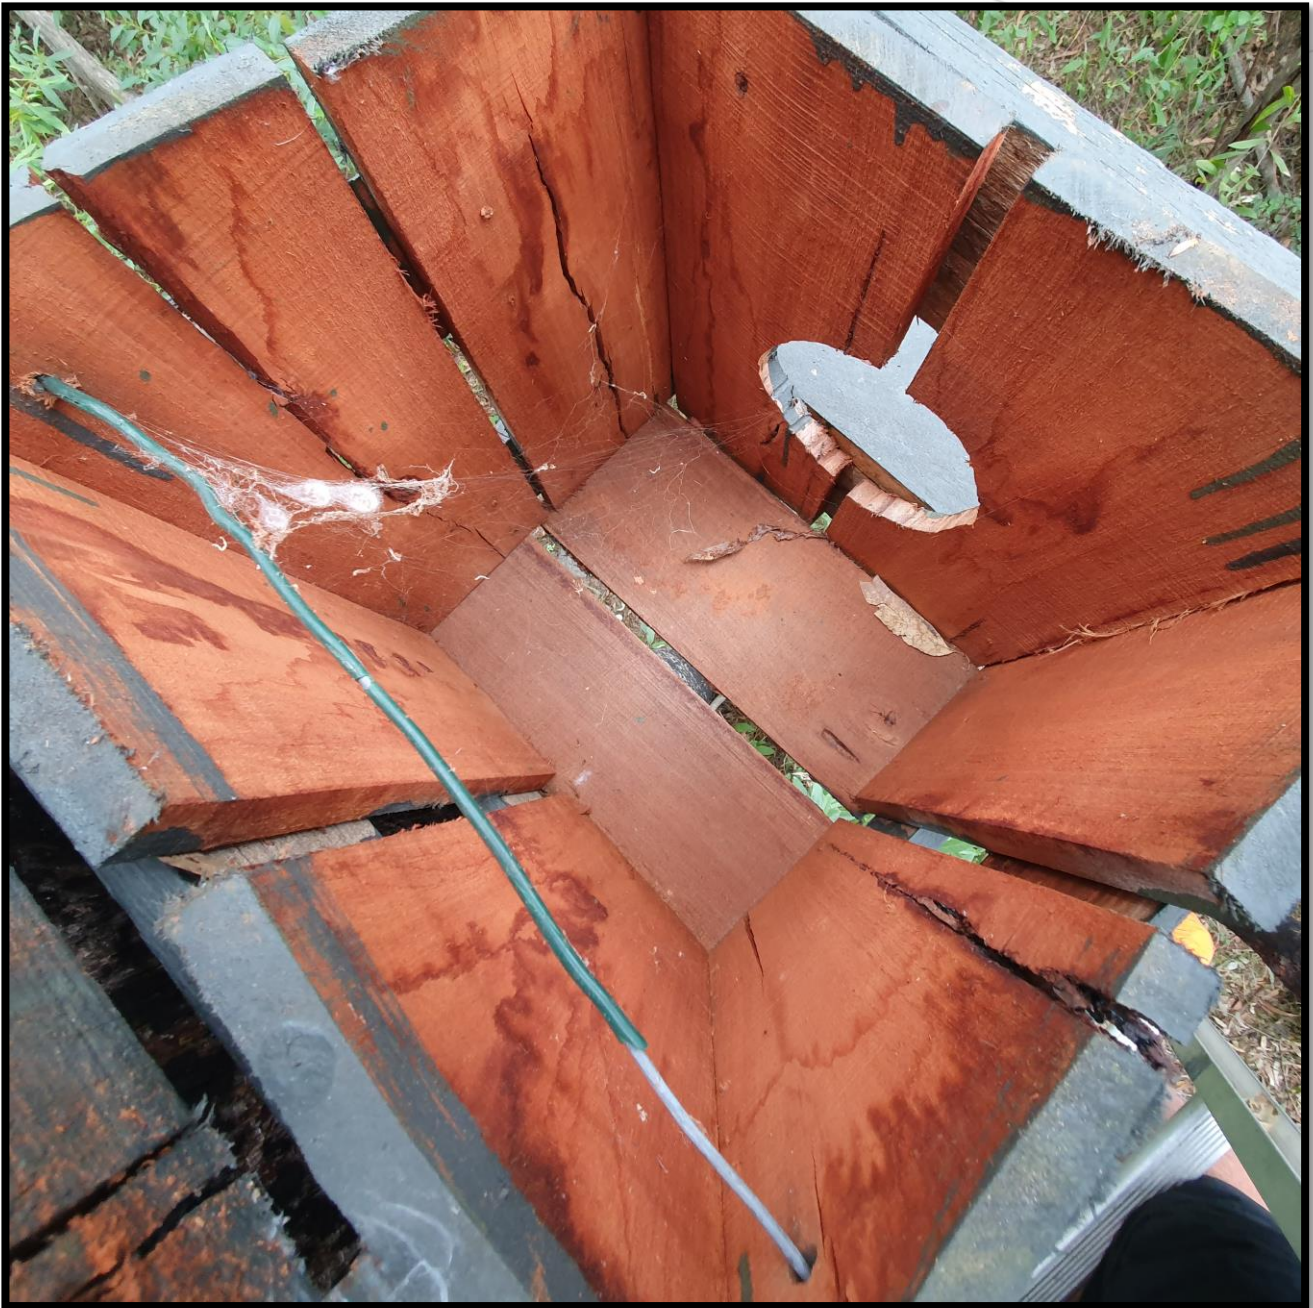
**Plate 4-1.** Example of nest box identified for “cladding” to reduce the gaps that allow sunlight, wind and rain egress.

Most of the nest box maintenance requirements were straight forward with some rewiring and repositioning works. Most importantly, all of the 84 boxes remain in place and considered functional although the parrot box from the original stage 1 installation works is close to failing due to termite damage. It was previously discussed about the construction of some nest boxes used in Stage 2 and their functionality due to splits and large openings allowing light and weather to penetrate the nest box. Material to clad 10 of these nest boxes should form part of the next round of monitoring.

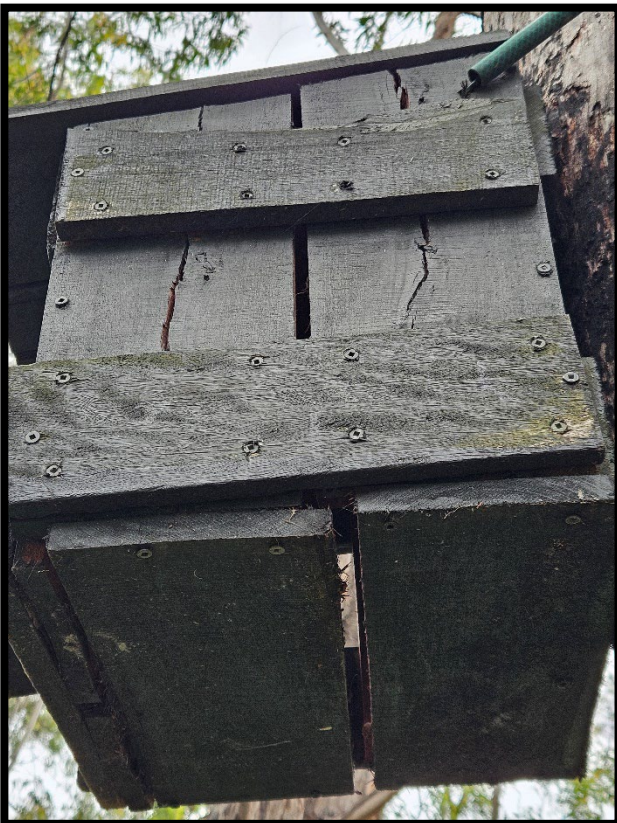
A number of the newly installed nest boxes have been constructed in such a way that leaves large gaps present in the floor and walls of the nest box, or with the drying of the timber, they have split (Plate 3-1). Some maintenance intervention is required on 12 of these boxes with the most practical solution installing a new piece of timber over the gap (i.e. cladding).

**Plate 3-1.** Nest box with excessive splits allowing light, rain and wind into the box.

1. Install a new parrot box in Stage 1 area to replace the one that has been consumed by termites.
2. Install cladding material (timber and screw or glue) to close up obvious gaps in 12 of the identified nest boxes.
